AT32F415 device limitations

Device identification

This errata sheet applies to Artery AT32F415 microcontrollers based on an ARM™ 32-bit Cortex®-M4 core.

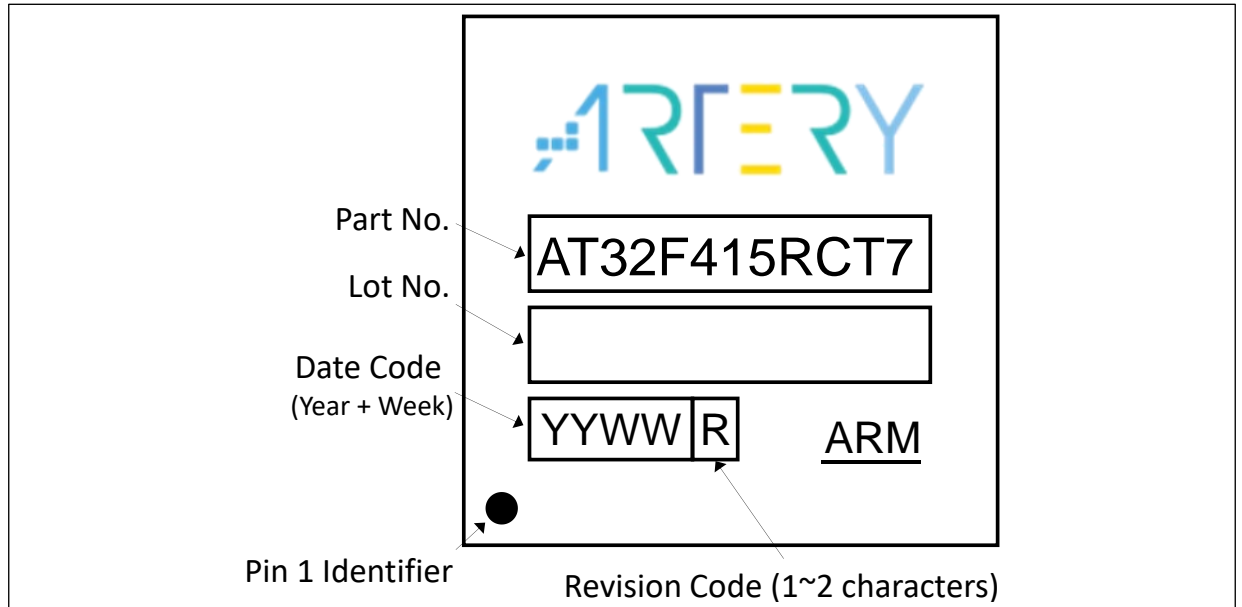
Figure 1. Package label (top view)

Figure 1 shows the location of revision code on AT32F415 device marking. The first code is R (revision code). For example, if B is shown in the R location, it means that the hardware revision of this device is silicon B.
