AT32F403A/407 device limitations

This errata sheet applies to the version of A & B of ARTERY AT32F403A/407 series. This series features an ARM™ 32-bit Cortex®-M4 core.

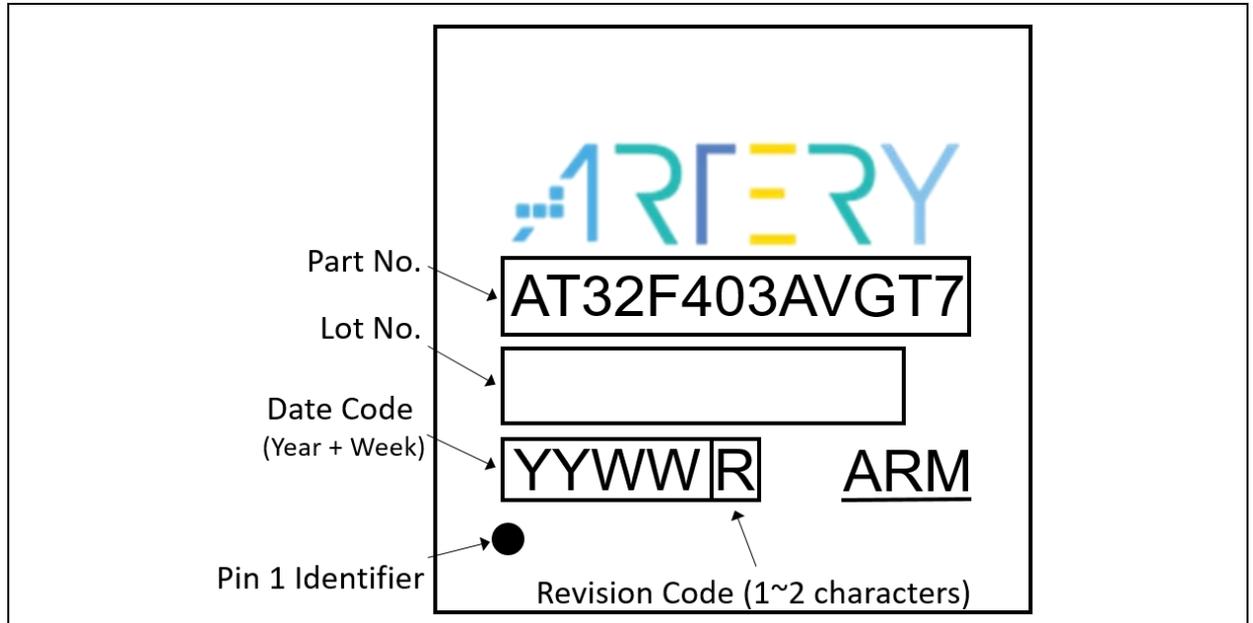
Figure 1. Device marking (Top view)

Figure 1 shows the revision code on AT32F403A device marking. The first code is R (revision code). For example, if “A” were shown at “R” location, it means that the hardware revision of this device is silicon A.
